**Siskiyou County**  
**Planning Commission Supplemental Staff Report**  
**August 21, 2024**

**New Business Agenda Item No. 2.4**  
**McLauglin Quarry (UP-82-23) and SP-24-02**

**Supplement to the Annual Inspection Report**  
**McLaughlin Quarry; California Mine ID# 91-47-0027**  
**October 3, 2011**

**Photo Supplement to the 2011 Annual Inspection Report**  
**McLaughlin Quarry; California Mine ID# 91-47-0027**  
**October 3, 2011**

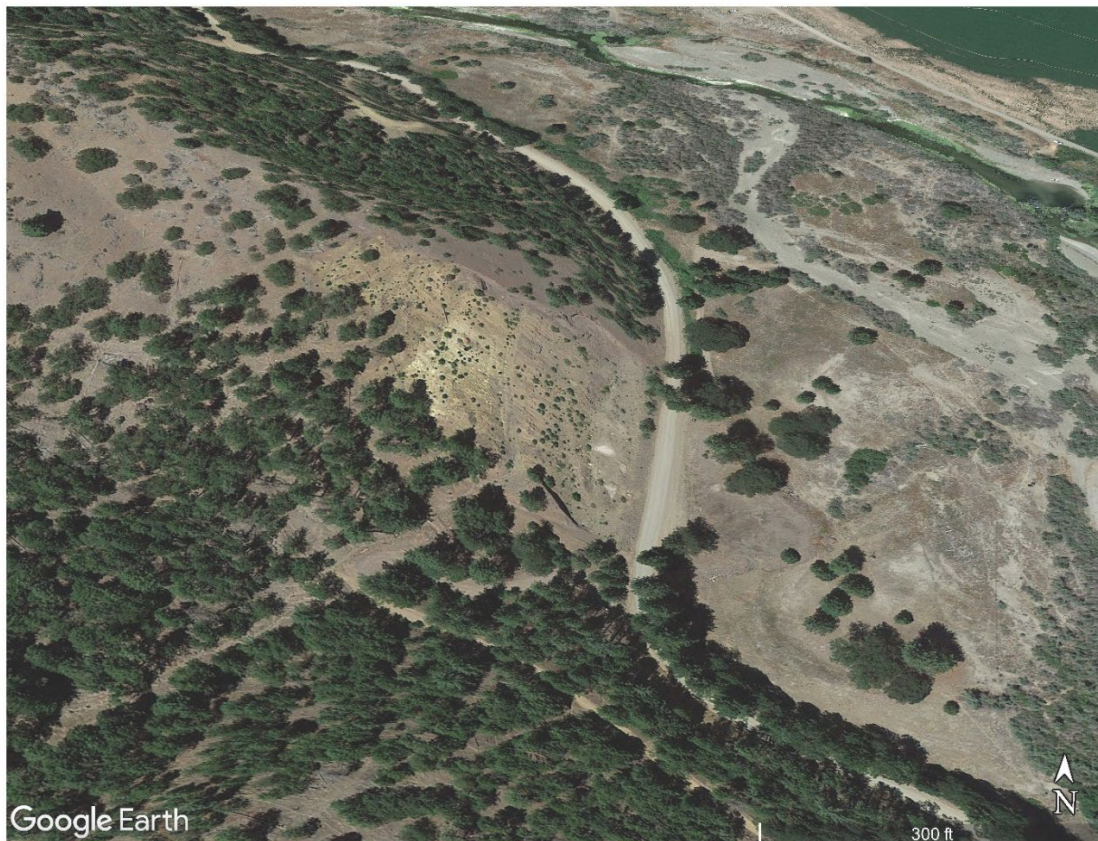
**Figure 2: McLaughlin Quarry - Aerial Image showing existing site conditions (7/16/2022)**

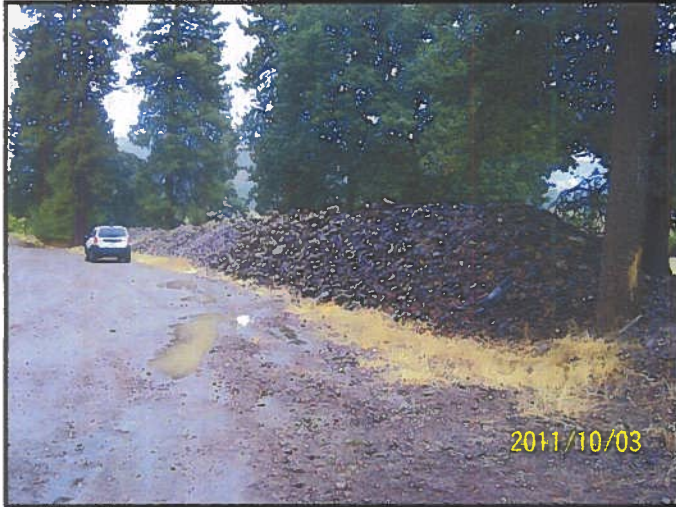
**Photograph #1**

B. A berm of waste rock, approximately 5 feet high, has been placed along the county road. The constructed berm restricts access to the pit floor of this quarry as per the fencing requirement of the approved reclamation plan and as agreed to by the operator, property owner and the lead agency. This constructed berm, which was later straightened by the County's Public Works Department, provides for an added measure of protection from a future slope failure or rock raveling from the mined slopes of this quarry. While the pit floor is sloped back towards the toe of the slope, the constructed berm further serves to contain storm runoff on site.

**View of berm place along the roadway to control access to property. Berm placed at the request of the owner.**

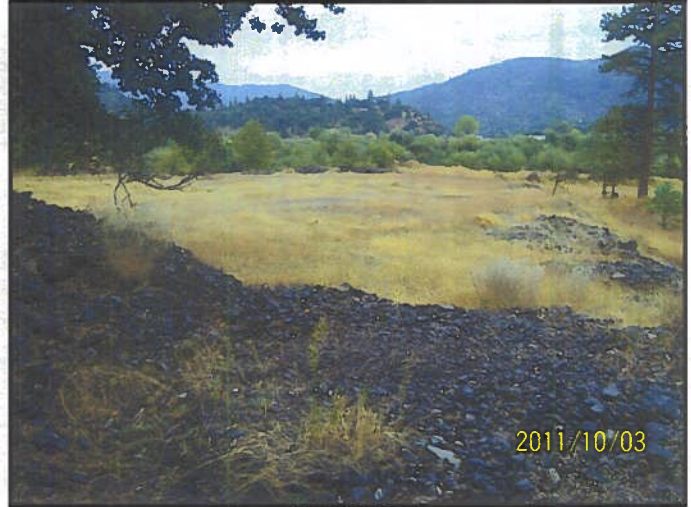
**Photograph #2**

E. A constructed berm of waste rock was placed along the east side of Lighthill Grade Road by the operator. This area lies outside of the boundary of the mine and was constructed per a request from the prior owner of this parcel as a deterrent to public access to this privately owned land and the illegal dumping of refuse which had been occurring prior to the construction of this barrier. The Public Works Department has acknowledged that they do not have an issue with the constructed barrier along this stretch of this roadway. Per a conversation with the operator, the current owner of the parcel is satisfied with the constructed berm in this current location. As this activity is outside of the approved mine site, prior concern that the operations had extended outside of the permitted area were raised by the lead agency per the 2008 Annual Inspection Report. Evidence provided indicates that this berm construction project outside of the mine site is not subject to the regulations and not a violation of SMARA or of the approved reclamation plan.

**View of the berm and the property east of the mine & road.**

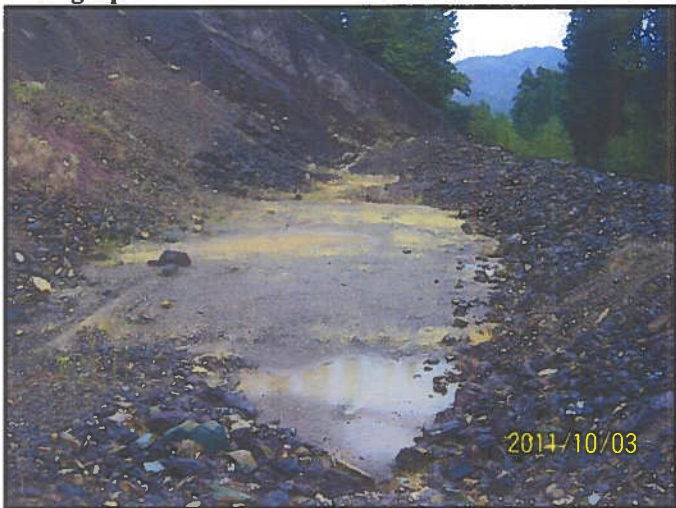
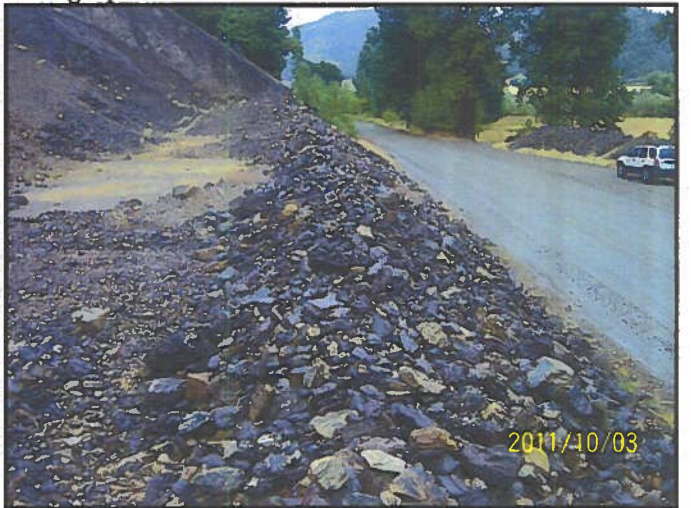
**Photos of the constructed berm to comply with the perimeter fence requirement of the reclamation plan. Berm also serves as a storm water retention basin and provides for an added measure of safety to rock fall or slope failure.**

Although OMR concurs with the lead agency that the site is reclaimed and the financial assurance mechanism can be released, continued monitoring of the site should be performed by the Siskiyou County Road Department. It is recommended that the Siskiyou County Road Department continue to monitor the site and perform any necessary maintenance of the berm and associated catchment area to protect public safety along Lighthill Road.

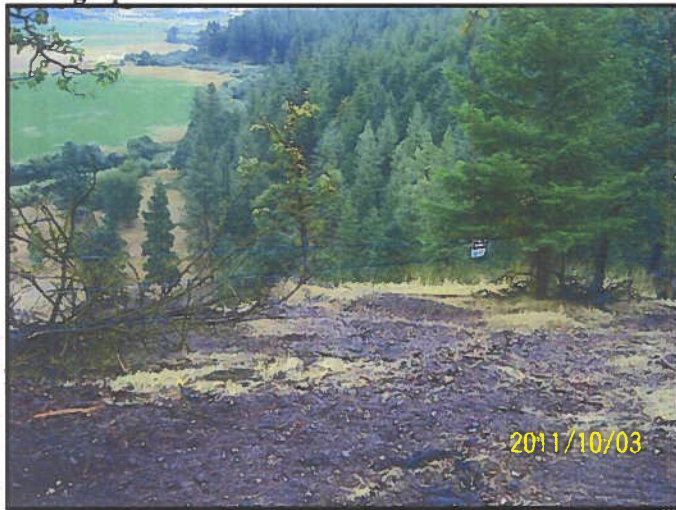
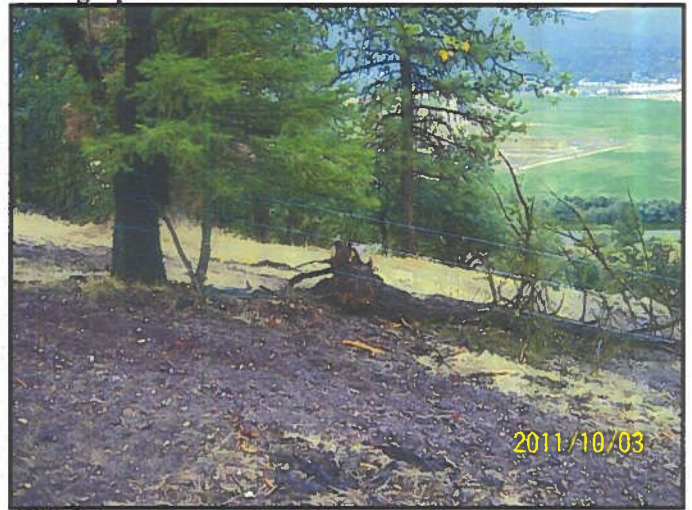
D. The reclamation plan calls for the construction of a perimeter fence around the perimeter of the quarry. The fencing requirement along the boundary adjacent to Lighthill Grade Road was established with the construction of the rock berm. As the reclamation plan does not provide a description of the type of fence to be constructed, it was agreed that a three strand wire fence would suffice around the remaining perimeter of the quarry boundary. The lead agency requested that the fence be signed at appropriate intervals warning the public of the danger present with regards to the cut slopes. It should be noted that the mine site is contained within a 47.3 acre, privately owned parcel. Observations conducted indicate that the fence has been constructed around the perimeter of the quarry as previously agreed to and as required per the approved reclamation plan.

**Photos of the upper portion of the mine site, above the cut slope of the quarry. Required perimeter three strand fence and signing requirement were noted as in compliance with the reclamation plan and lead agency agreement with the operator.**

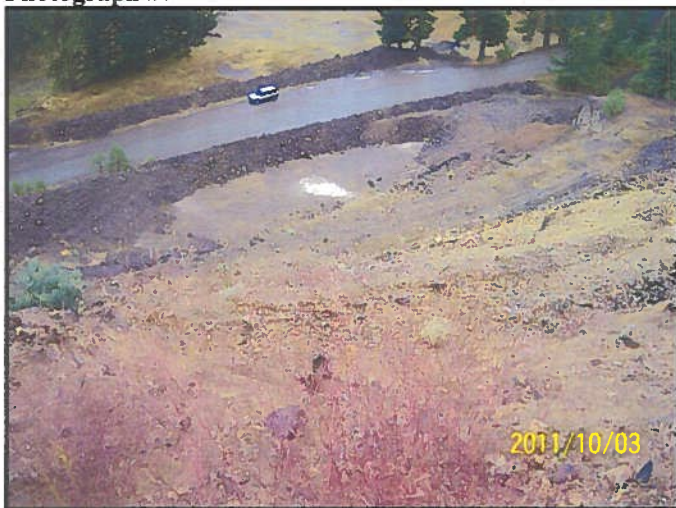
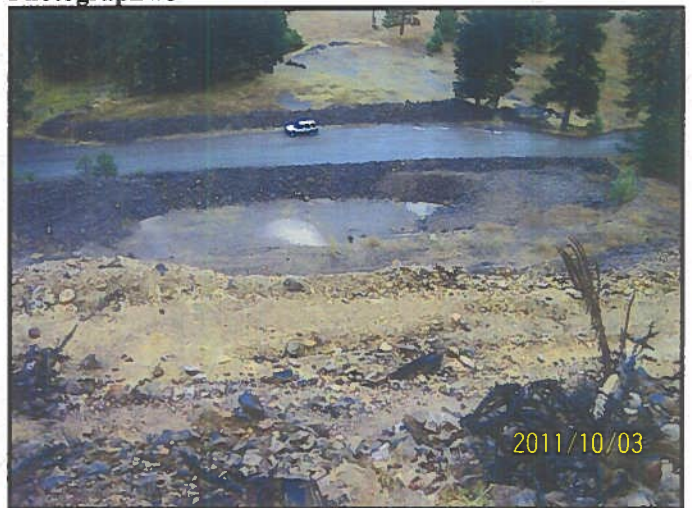
A. The mine site is closed and reclamation activities have been initiated by the operator. Reclamation activities have involved the construction of four (4) benches, approximately every 30-40 feet and 10+/- feet wide. The operator noted the construction of benches was suggested to him by a State Inspector as a means of stabilizing the final slope of this site. Review of the reclamation plan indicates a final slope configuration of 1H:2V. The instability of the slopes established by the operator as the proposed final slope configuration for this site was a concern noted in the 2008 and 2009 inspection reports. The operator was advised to provide a slope stability report prepared by a geotechnical professional for these final slopes. The County then met with the operator regarding the stability issue and offered the assistance of the County's Public Works Department in addressing the slope issue for this site. A report was submitted by the Director of the County's Public Works Department. A review of this report by the lead agency for the County's SMARA program noted that the current condition of the slopes are only marginally stable and periodic rock fall and debris slides could be expected.

**Views of the slopes of the quarry from the top of the cut face looking east with Lighthill Grade Road located at the bottom of the slope.**

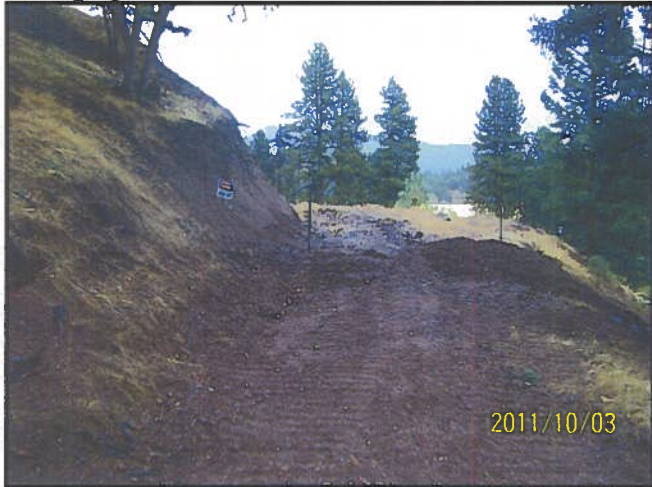
**Photograph #9**

**View of the upper bench from the access ramp road.**

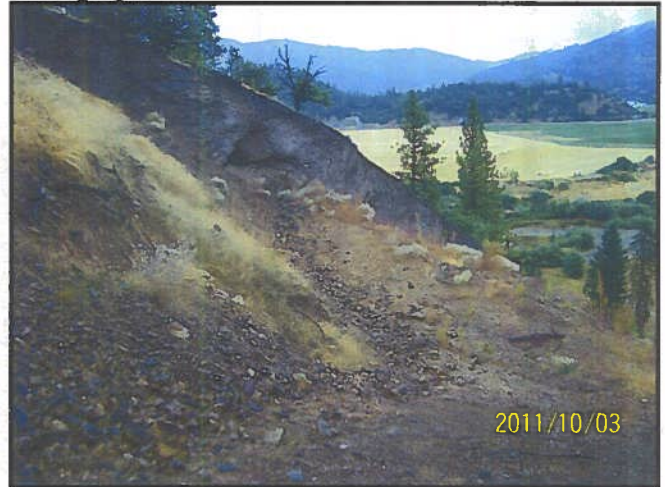
**Photograph #10**

**View of a lower bench looking south across the quarry site.**

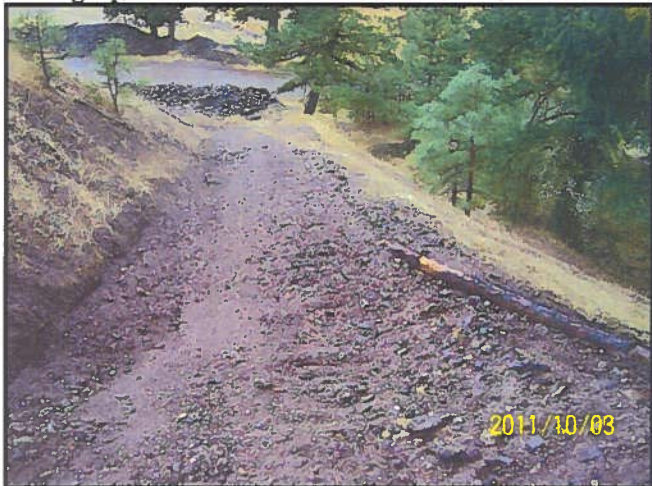
**Photograph #11**

C. The quarry's access ramp is present along the southern edge of the quarry. The lower ramp access appears to drain storm runoff onto the floor of the pit, with the upper access road being out sloped, appears to drain towards a seasonal drainage located parallel to the access ramp. While the reclamation plan does not address off site sedimentation and erosion potential due to past mining activities, the operation is subject to regulations with regards to water quality as implemented by the Regional Water Quality Control Board (RWQCB) if runoff from this mining site impacts water quality.

**View of the lower access ramp road.**

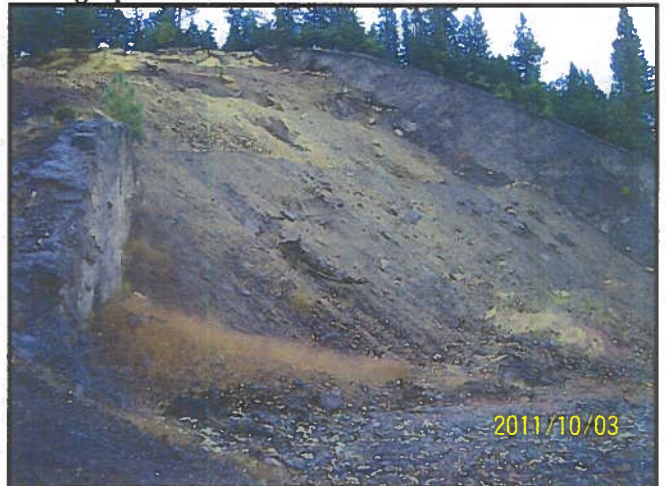
**Photograph #12**

**View of the quarry from the berm along the county road.**

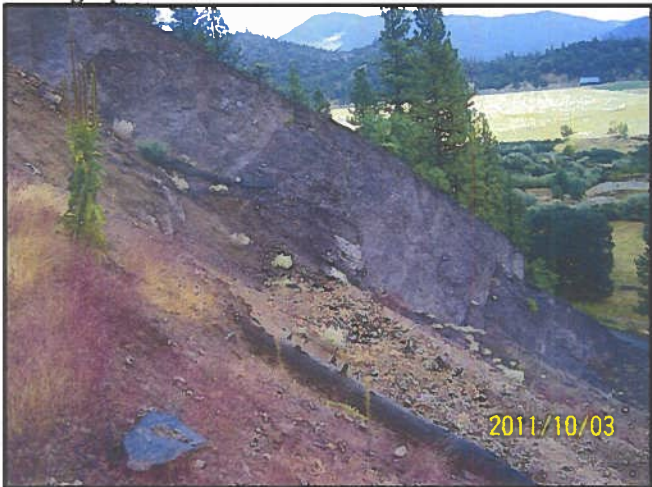
**Photograph #13**

**Looking northeast across the middle section of the quarry. Lighthill Grade Road with the quarry on the right in photo.**  
**Exhibit B**
